### Salterfen Lock

**LOUTH  
NAVIGATION  
TRUST**

Grid Reference: **TF 357 902**

State of Lock: Poor

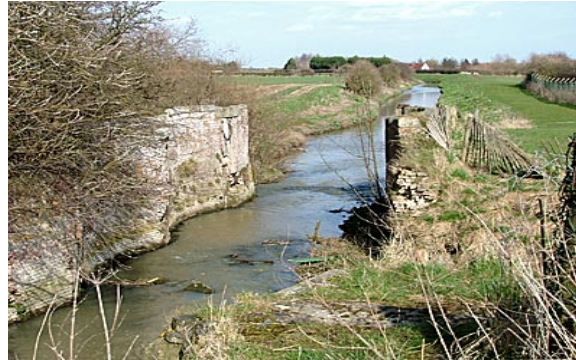
Salterfen Lock - approach from upstream

The approach from upstream, above, shows the poor state that this very beautiful lock is in. The image on the right showing the north-west wall of the lock, gives some idea of how the brickwork in the barrels has deteriorated. This presents the Trust with a major problem. Because the lock is listed grade II, it will have to be restored completely to its original design. Fortunately there are no major impediments such as bridges or roads nearby. However, downstream on the south-east bank there is a sewage treatment works which discharges clear effluent into the canal immediately below the down-stream approach. This could present the Trust with restoration problems and will involve detailed liaison with the Drainage Board and the Environment Agency.

Future Plans: Complete Restoration

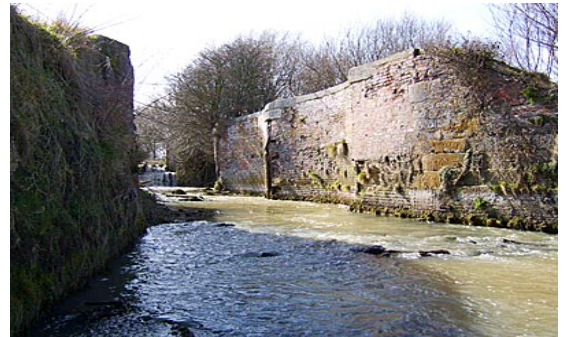
The image to the left shows a detail of the north-west wall, where a bow on the barrels has started to buckle and crumble. Note the state of the supporting timber which has been in place since 1770, but will now have to be replaced. It is vital for the Trust to start restoration as soon as is possible to prevent further erosion.
